Home Inspection Report

**1845 Winding Trail
Briarcliff Manor,
NY**

Inspected on Mon, Jun 30 2014 at 9:00 AM

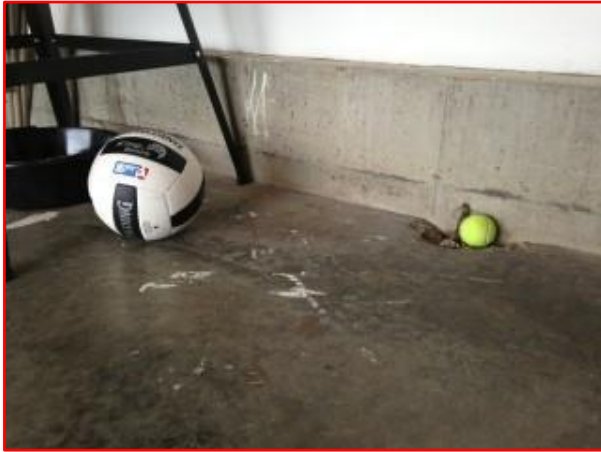
Figure 1-1

1) Garage floor slab has settled approximately 3" at house. This is not a structural issue but rather a drainage issue. Water and snow from cars will drain toward the home instead of toward the door. Likely caused by compaction of fill below the floor. Contact a concrete lifting (Mudjacking) contractor for costs and options for repair.

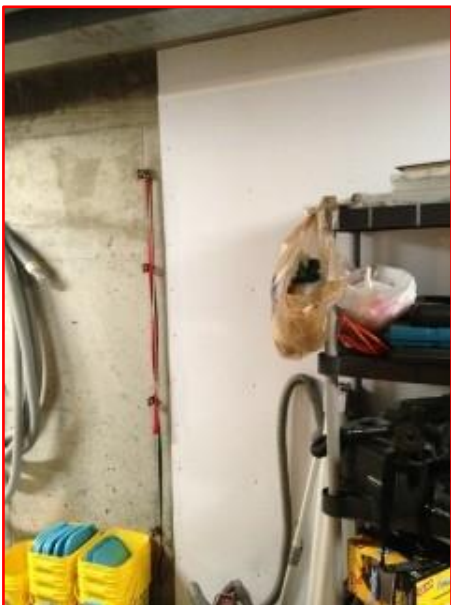
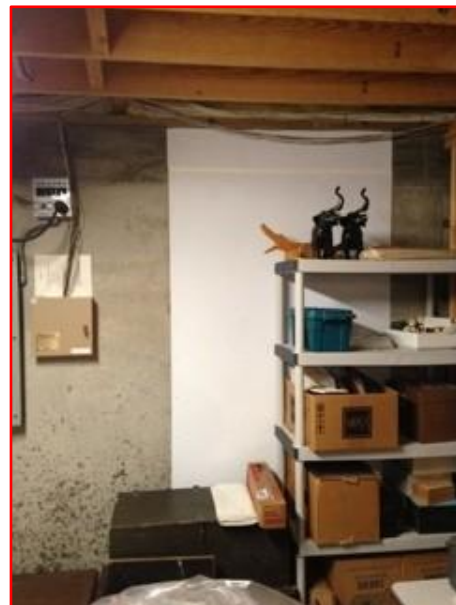
2) Waterproofing panels have been installed at front and left side of unfinished basement. This indicates likely water penetration into the basement at some time. Obtain and transfer and available warranties.

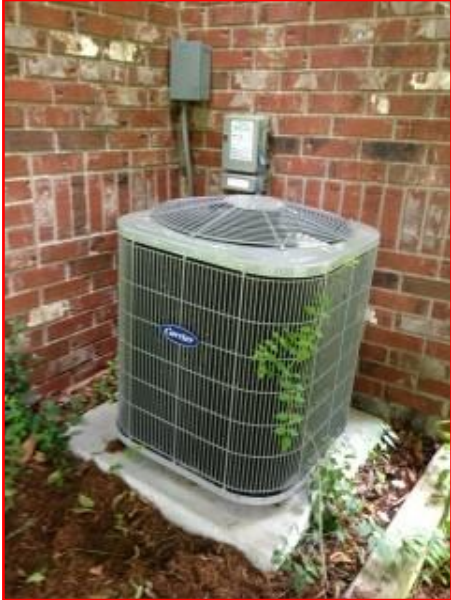
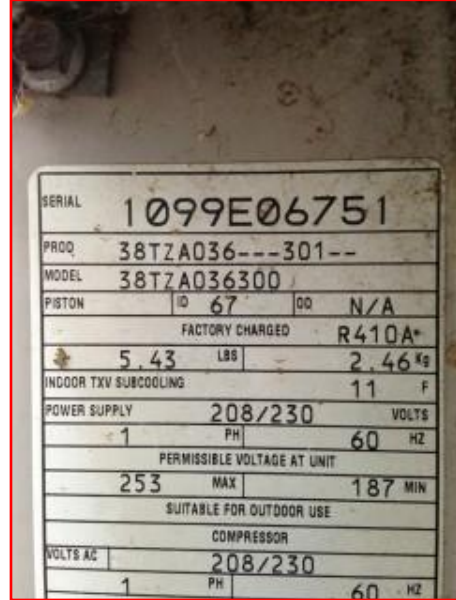
3) Ac unit operates as expected but is nearing the end of its life expectancy. Plan to replace in near future.

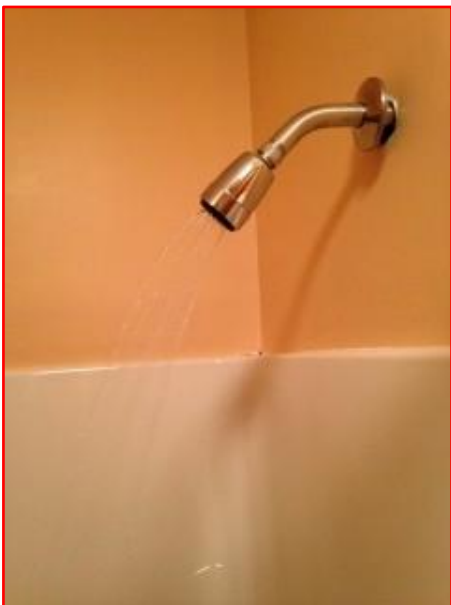
Figure 4-1

4) Hall bath shower head has poor flow. Other fixtures in this group are acceptable and flow does not change when other fixtures are turned on or off. Have checked and repaired by a licensed plumber. Likely a malfunctioning anti scald valve.

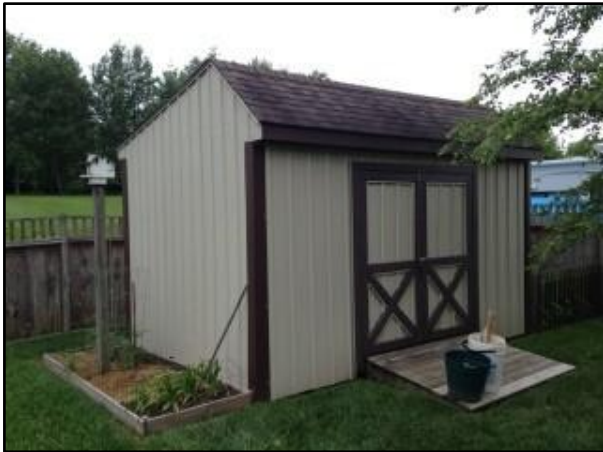
Figure 1-1

Storage shed is located on the property but was not inspected. Beyond the scope of a home inspection.

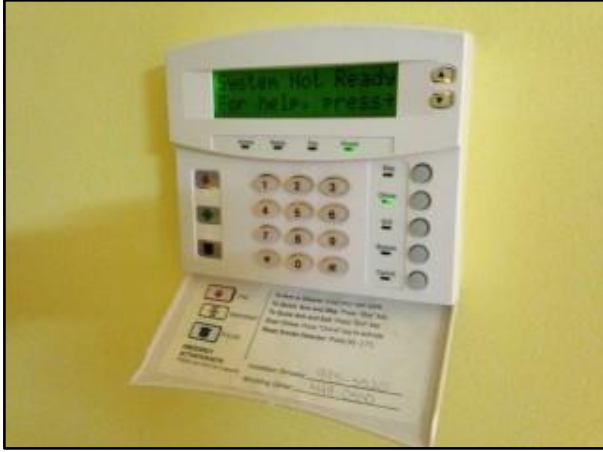
Figure 2-1

i Comment 2:
Security system is installed but was not inspected. Obtain all information available from owner or installer.

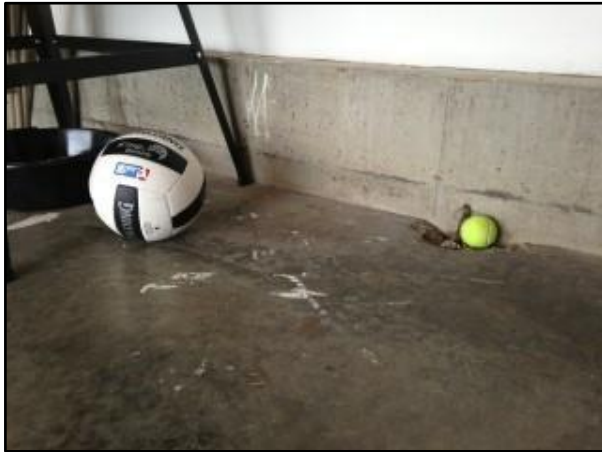
Figure 3-1

Garage floor slab has settled approximately 3" at house. This is not a structural issue but rather a drainage issue. Water and snow from cars will drain toward the home instead of toward the door. Likely caused by compaction of fill below the floor. Contact a concrete lifting (Mudjacking) contractor for costs and options for repair.

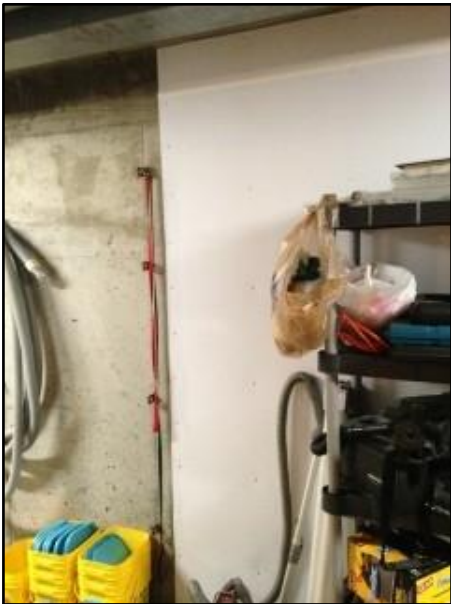
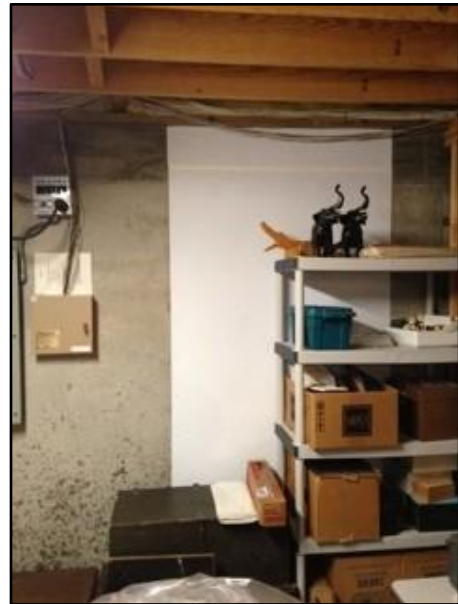
Waterproofing panels have been installed at front and left side of unfinished basement. This indicates likely water penetration into the basement at some time. Obtain and transfer and available warranties.

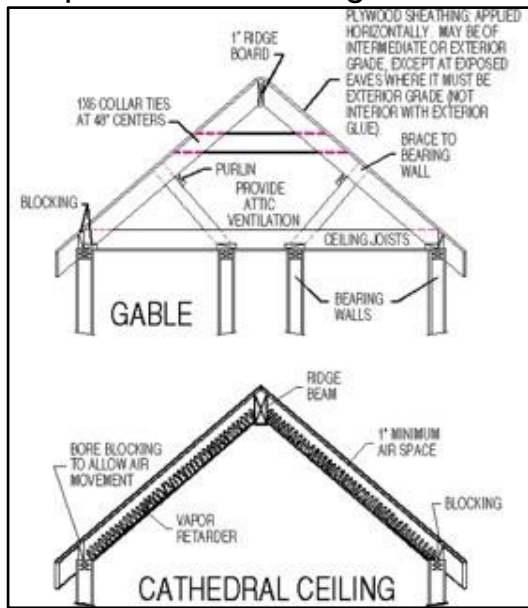
Figure 6-1

Comment 6:
Example of roof framing.

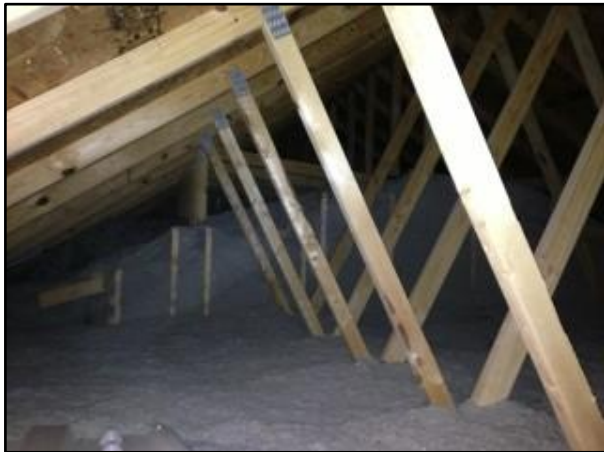
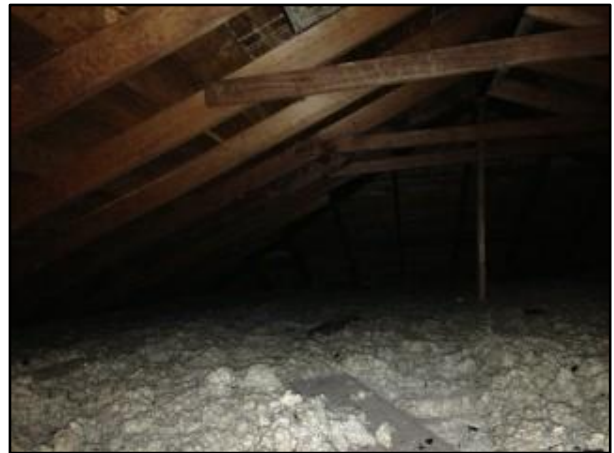
Comment 7:
View inside the attic. Ok.

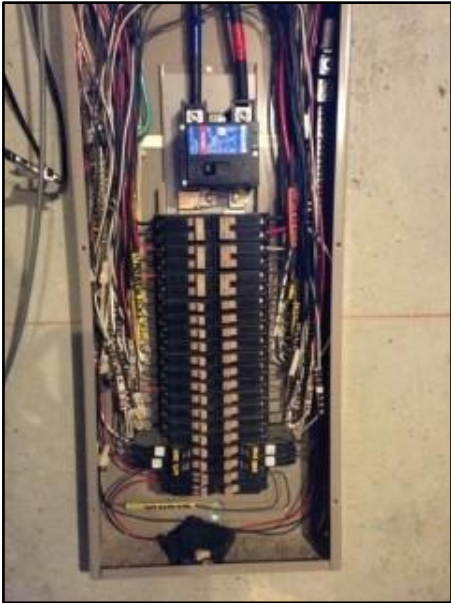
Figure 8-1

Comment 8:
Inside main electrical panel. Ok.

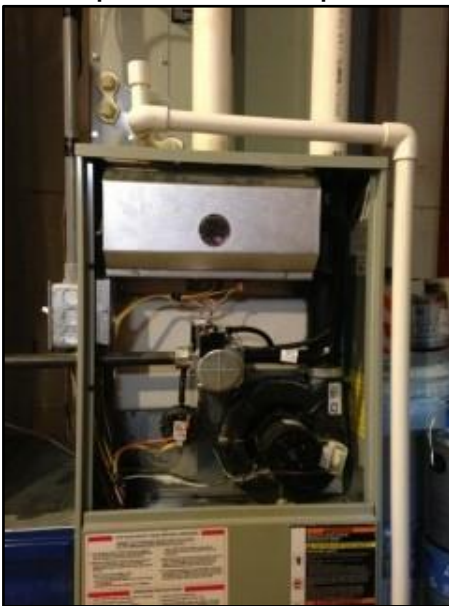
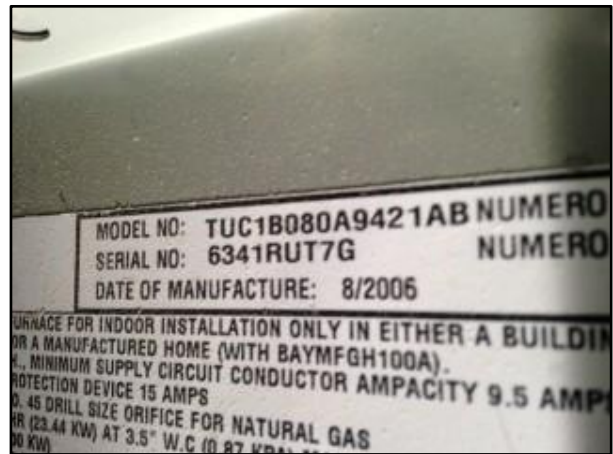
Comment 9:
Furnace operates as expected. Ok.

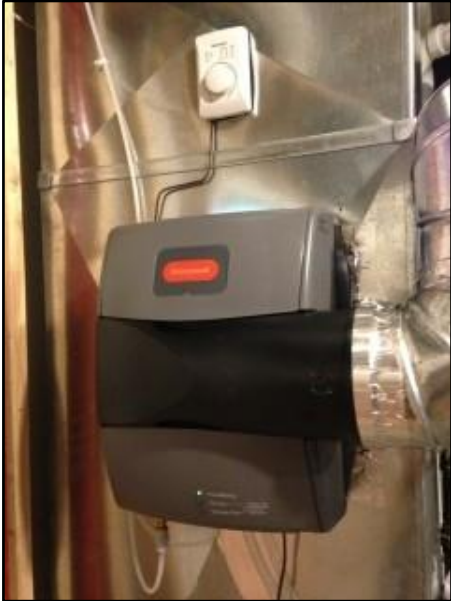
Figure 10-1

Humidifier is present and operates as expected. Media will need to be changed it cleaned yearly.

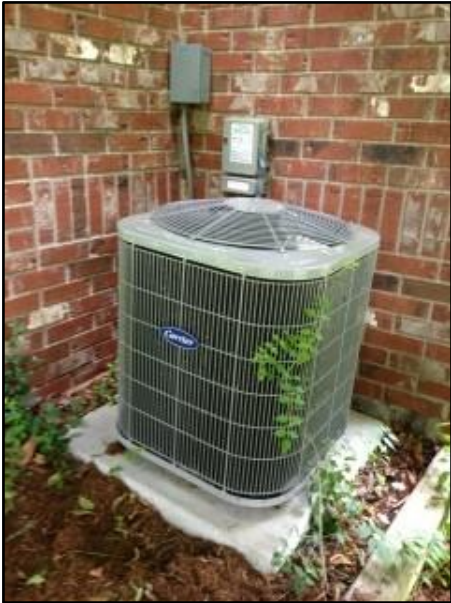
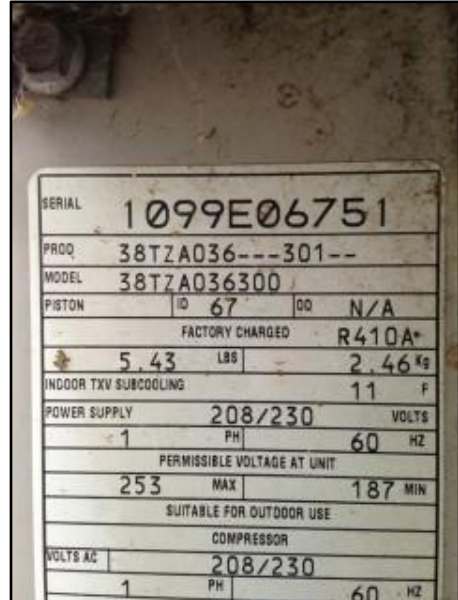
Ac unit operates as expected but is nearing the end of its life expectancy. Plan to replace in near future.

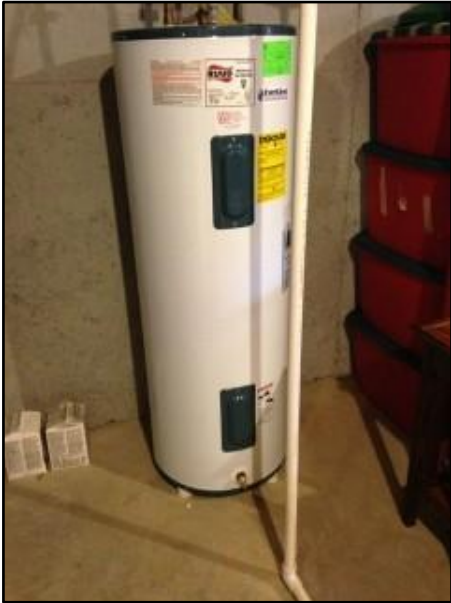
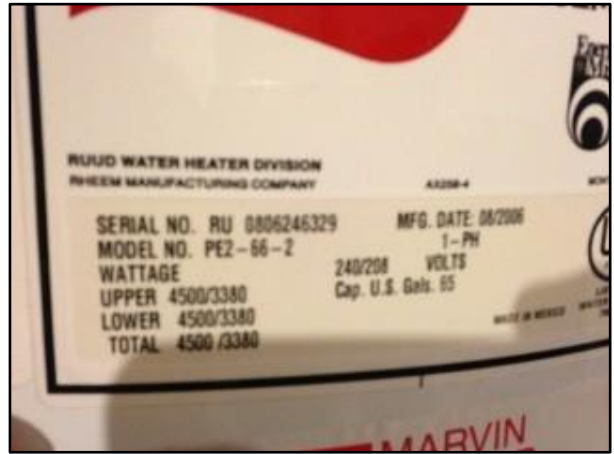
Comment 12:
Water heater operates as expected.

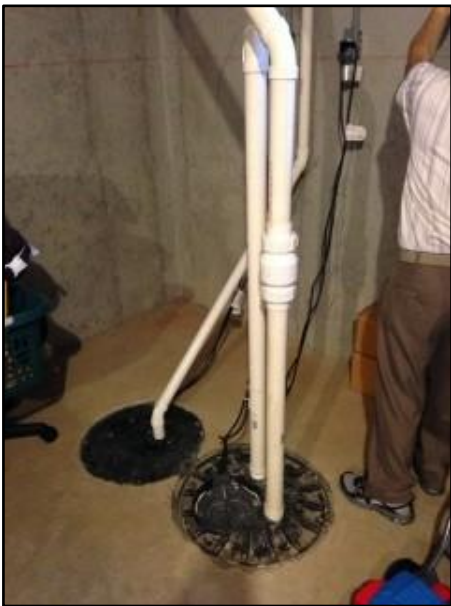
Figure 13-1

Comment 13:
Sewage ejector is located in basement. Be careful what is flushed as some items could damage unit. Do not use basement plumbing when power is out.

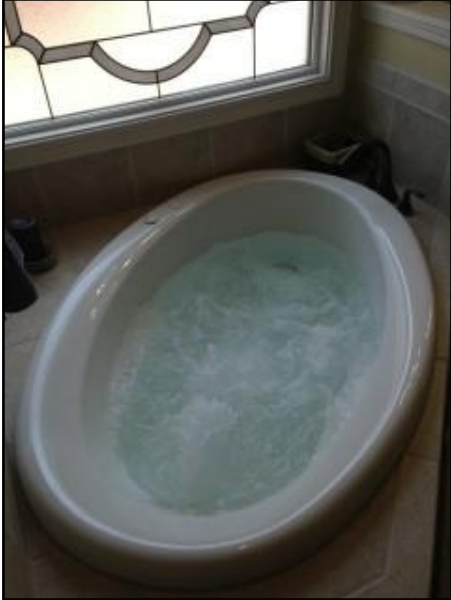
Figure 14-1

Whirlpool tub operates as expected. Fill with water and a cup of bleach. Run for 1/2 hour then drain and fill with clean water to rinse.

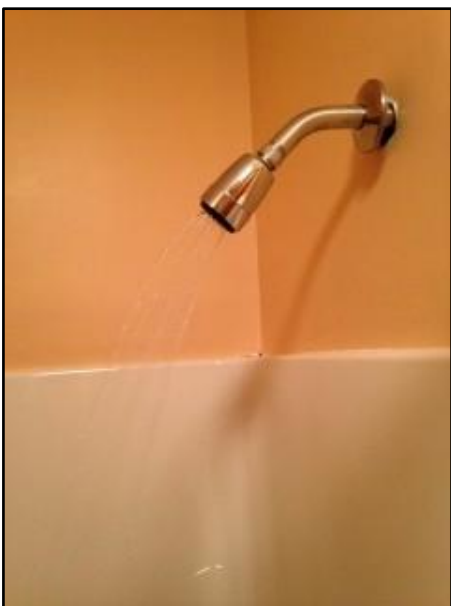
Figure 15-1

Hall bath shower head has poor flow. Other fixtures in this group are acceptable and flow does not change when other fixtures are turned on or off. Have checked and repaired by a licensed plumber. Likely a malfunctioning anti scald valve.

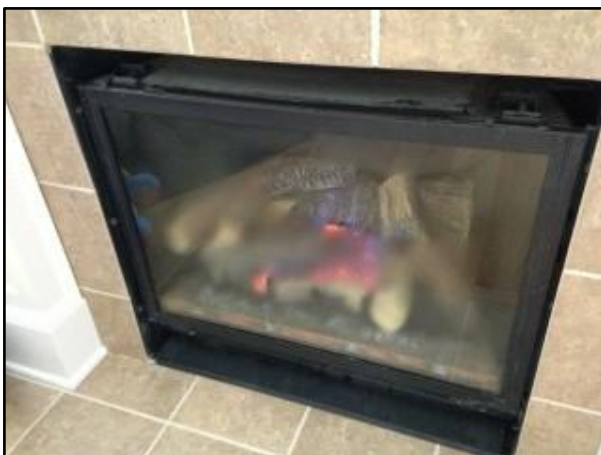
Figure 17-1

Comment 17:
Gas logs operate as expected. Ok.
